Analysis of DAA Alerting and Guidance using reconstructed trajectories that resulted in (N)MACs

In this paper it is analyzed how the alerting and guidance provided by a Detect and Avoid system meeting the minimum operational performance requirements specified in RTCA DO-365 could have contributed to the prevention of 8 (N)MACs that occurred between 1972 and 2015.

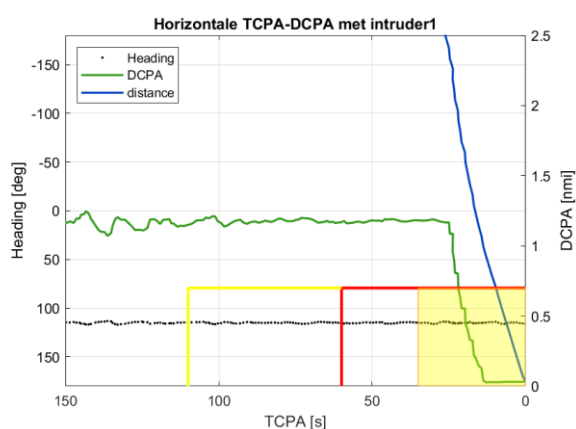
Figure 5. TCPA-DCPA chart for reconstructed Monks Corner trajectories.

The TCPA-DCPA chart in Fig. 5 shows how the predicted separation remained a little over 1 NM until TCPA was about 25 seconds. The TCPA-VCPA chart in Fig. 6 shows that vertical separation was decreasing. Given the small TCPA at which predicted DCPA decreases below the alert threshold, there would have been no Corrective Alert and the Warning Alert would have been provided at a very late moment. It is questionable whether an alert this late could have helped the pilots⁸ prevent the (N)MAC. However, given the fact that at a TCPA of 100 [s] the vertical separation was already within 450 ft, peripheral guidance bands would have been present on the DAA display. The snapshot of the CDTI that was taken at a TCPA of 85 [s] shows the yellow heading guidance to the left of ownship track that the F-16 pilot would have seen. As TCPA decreases, the color of the heading guidance band changes to red. This situation is depicted in Fig. 8. Based on these situation awareness cues, it is hypothesized that the availability of a DAA display in the F-16 would likely have prevented the pilot from deciding to turn left.

The TCPA-DCPA chart for the Etten-Leur midair (Fig. 9) is similar to the TCPA-DCPA chart for the Moncks Corner midair (Fig. 5). At a very low TCPA, the maneuver of the F-16 causes predicted DCPA to decrease below the Warning Alert threshold.

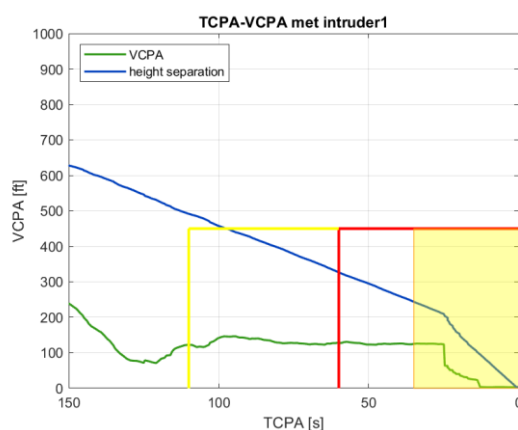
Figure 6. TCPA-VCPA chart for reconstructed Monks Corner trajectories.

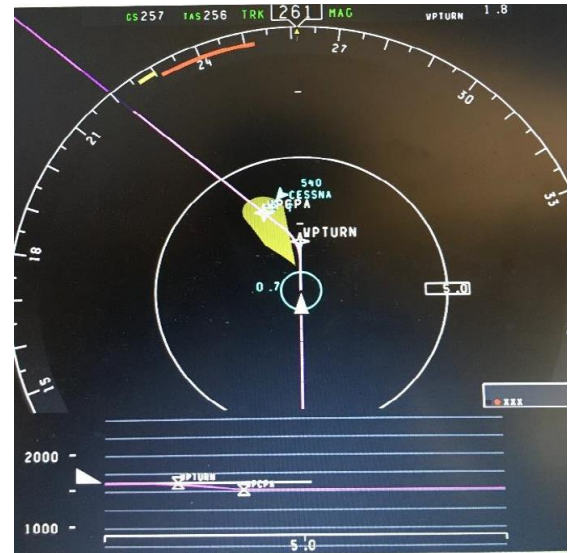
Figure 8. DAA display for F-16, Moncks Corner, TCPA 40

The snapshots in Figure 7 and 8 give an indication of the DAA information the pilot would have been provided with. The key is the location of the guidance bands relative to ownship track. In the next example, a time-history of these guidance bands is used as an alternative to a sequence of snapshots.

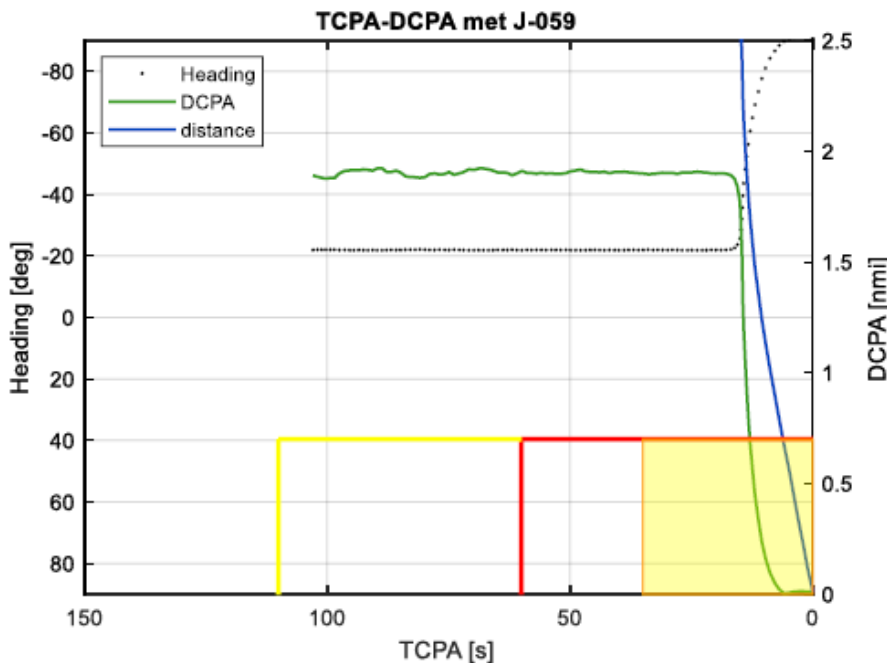
Figure 9. TCPA-DCPA chart for reconstructed Etten-Leur trajectories.

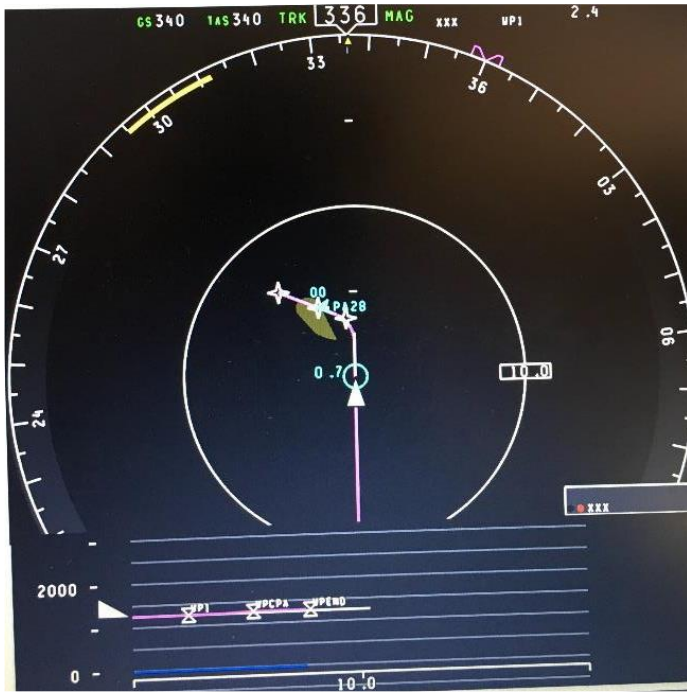
Figure 10. DAA display for F-16, Etten-Leur, TCPA 40.

Figure 10 shows what a DAA display in the F-16 would have depicted just before the left turn.

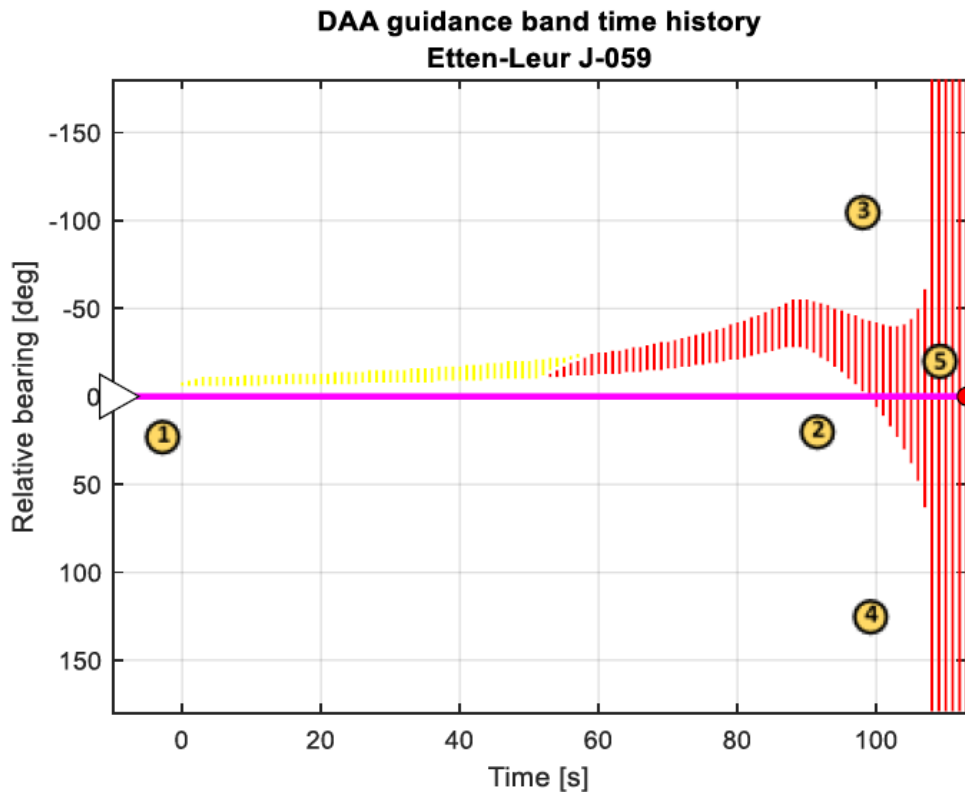
Figure 11. Guidance band time-history for DAA display on board F-16 preceding Etten-Leur (N)MAC

Figure 11 shows the time-history of the guidance band. On the horizontal axis, $t=0$ represents the first moment a peripheral guidance band is depicted. As can be seen, around $t=90$ the peripheral guidance band is completely red and extends from about 25 to 50 degrees to the left of ownship track. Around this time, the F-16 pilot turns left. Similar to the midair at Moncks Corner, it is hypothesized that the availability of a DAA display in the F-16 would likely have prevented the pilot from deciding to turn left.

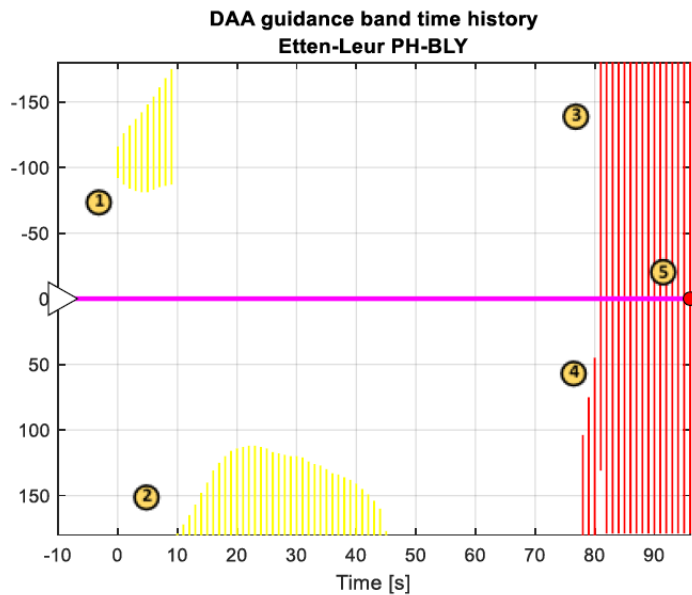
Figure 12. Guidance band time-history for DAA display on board Piper PA28 preceding Etten-Leur MAC

Figure 12 shows the guidance band time-history for a DAA display on board the Piper PA28.

From this time-history it can be concluded that before the Warning Alert (that was declared only briefly before the MAC), no other cues were available to the pilot of the Piper PA28.

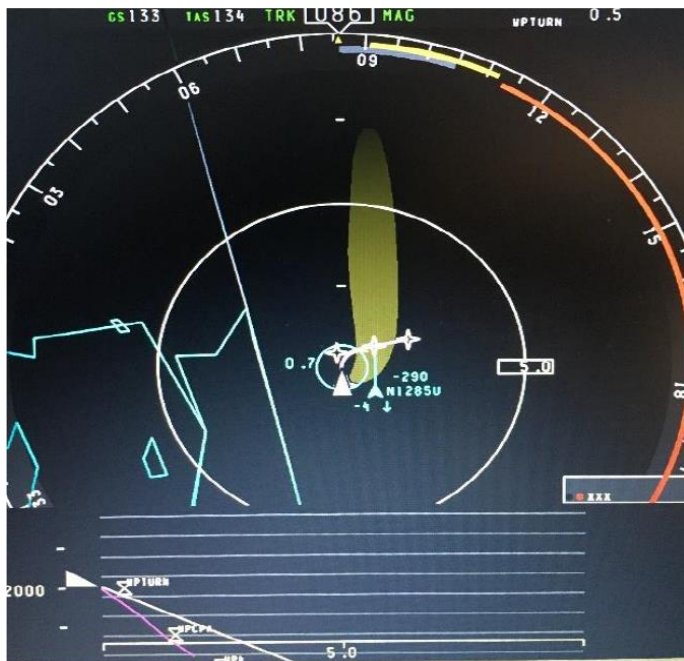
Figure 13. ND showing that a turn to the right will result in an alert

Figure 13 shows what a DAA display in the Sabreliner would have depicted before the turn to the right was made that resulted in the MAC near San Diego on August 16, 2015. Close to current ownship track the heading band is already yellow, and after 20 degrees changes to red.

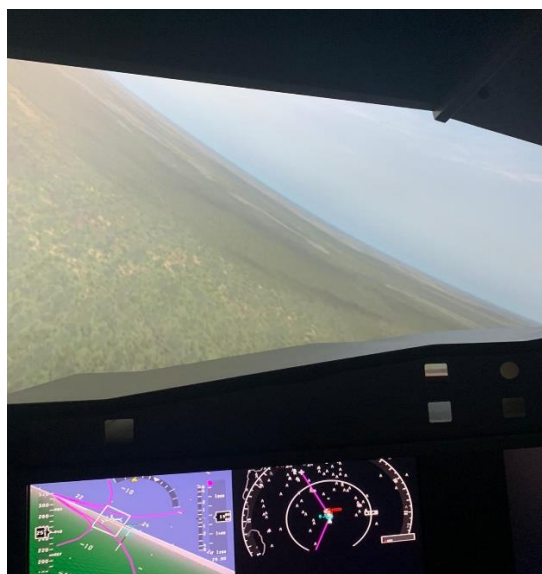
Figure 16. Research flightdeck at TU Berlin.

To replicate the situation as seen from the flightdeck, the UAV GCS simulator at NLDA was connected to a research flightdeck at TU Berlin. Tests were performed to measure latency and the ability to re-create (N)MAC geometries, and it was concluded that even with two asynchronous simulations it would be possible to bring the simulated positions within (N)MAC distance. Figure 16 shows a view from the research flightdeck of TU Berlin during the turn into the Cessna 150M (Moncks Corner). The technical feasibility was demonstrated and this capability proved very useful to illustrate the contribution of a DAA display using simulated (N)MAC geometries.
